# The Reasons of Steam Pipeline Elbow Rupture

The goal of this dissertation is to determine the reasons of the damage (crack) of the steam pipeline's elbow made of alloyed steel 13CrMo4-5 after 300 000 hours.

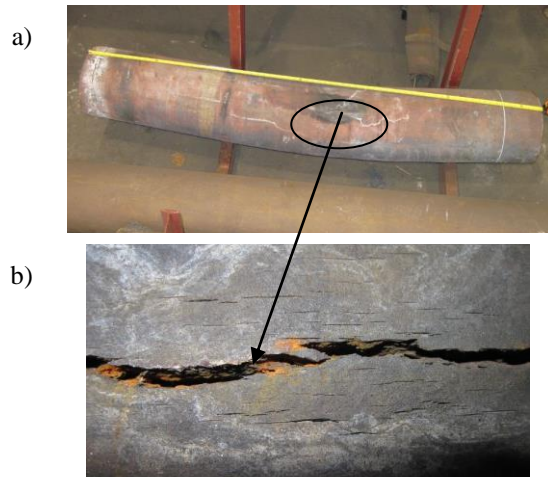
The photo of the steam pipeline elbow and the crack is being shown on the Figure 1.

Fig. 1. Pipeline elbow subjected to testing: a) overview; b) the elbow's crack area

The conducted tests proved, that the pipeline's elbow rupture happened as a result of complex tension system, which substantially exceeds the admissible tensions. One of the degradation factors was the natural and at the same time – considerable structure damage level, notes both in the damaged area (areas: a1; a2; a3) and outside the damaged area (areas b1; b2; b3).

On the basis of the conducted tests it may be stated, that the exploitation of the tested pipeline can be continued with maintaining certain exploitation regimes, with special consideration for pipeline's material temperature increase, which should not exceed 490°C. In the balance exploitation time, the use of the pipeline should be limited to minimum.

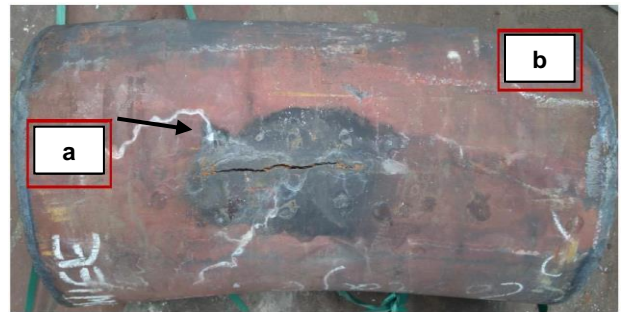
Fig. 2. (a, b) The areas from which samples were taken for mechanical properties testing: a) damaged area, b) not damaged area

Out of the data shown in the Tables 3-6 comes, that the 13CrMo4-5 steel material sampled from the place where crack occurs has lower yield strength  $R_{p0.2}$  and  $R_{p0.2}^{500C}$  of about 2%

from the requirement for the same steel in it's base state as per the standard PN-74/H-74252. The material sampled from the area without any internal damages complies with the requirement of mentioned above standard.

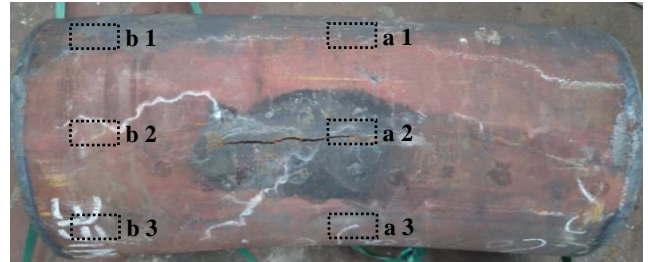
Fig. 3. The sampling places for representative samples for micro structure testing: a) damaged area, b) not damaged area

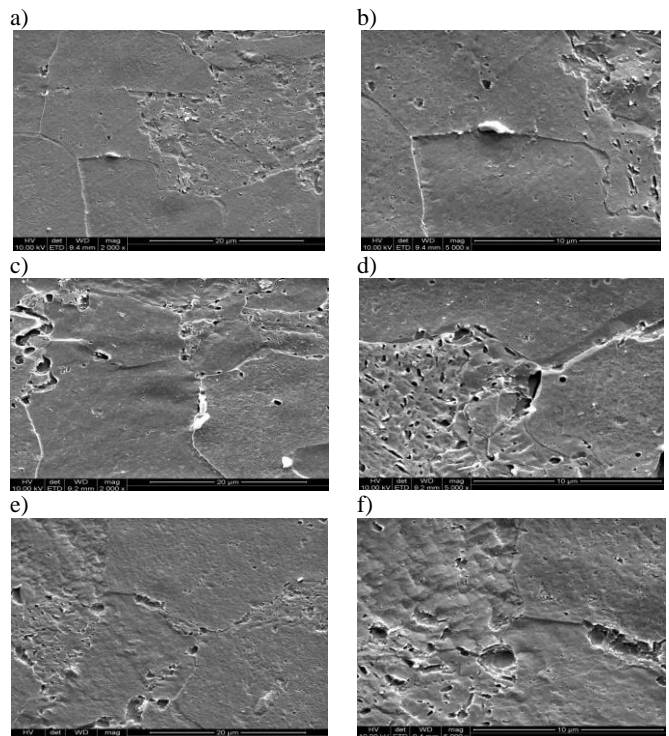
Fig. 4. The microstructure of the tested pipeline's elbow, from the area without the damage: a and b) area b1; c and d) area b2; e and f) area b3 with different magnitudes

Out of the micro structure tests it comes, that in the not damaged areas the structure depletion is the same as in the base material, and the changes are on the level I (Table 1) what equals to partial decomposition of bainite/perlite areas. In the areas where the damage was observed, the structure depletion level is B/1, and the micro structure changes are on the level I/II, what equals to decomposition of bainite/perlite secretions, and carbide balling, with distinctive micro-cracks net.

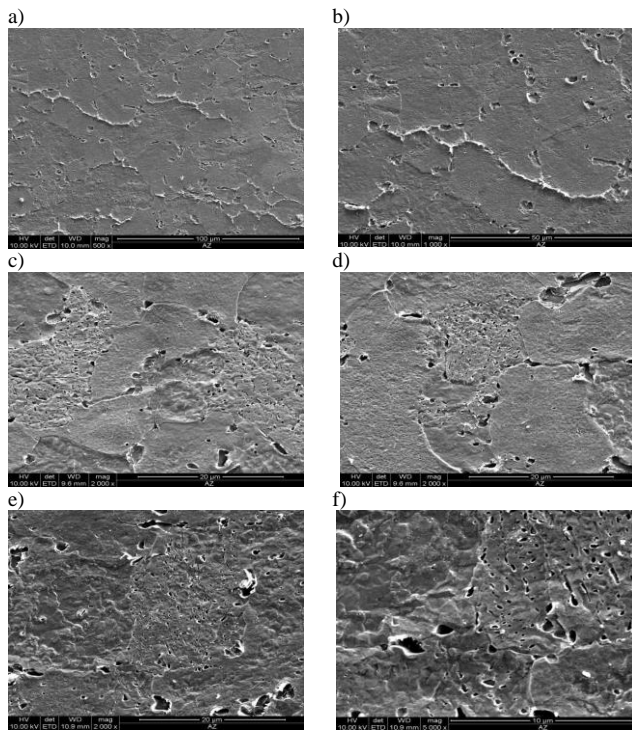
Fig. 5. The microstructure of the tested pipeline's elbow, from the area with the damage: a and b) area a1; c and d) area a2; e and f) area a3 with different magnitudes

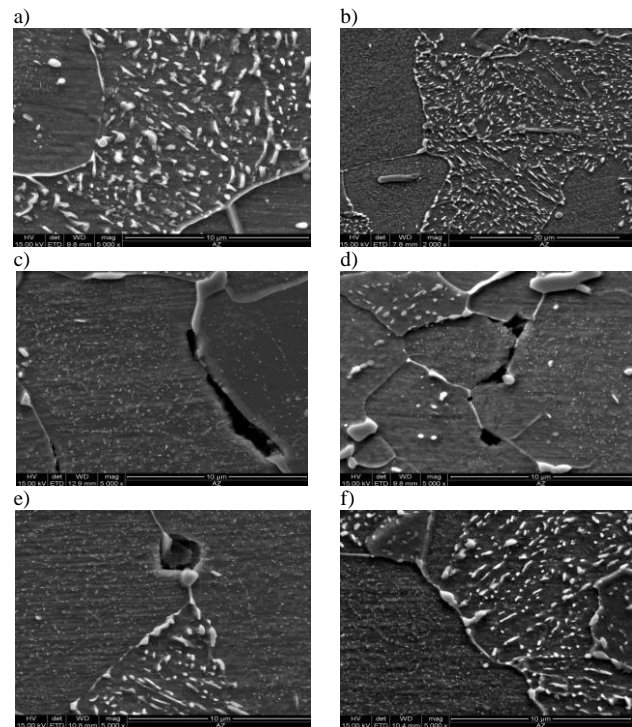
The SEM micro structures of the areas without damage and of those with damages are shown on the Figure 6.

Fig. 6. The microstructure of the tested pipeline's elbow: a, c, e) of the area without the damage, b, d, f) of the area with the damage
