# On Degradation of Cast Iron Surface- -Protective Paint Coat Joint

The paper is a presentation of a study on issues concerning degradation of protective paint coat having an adverse impact on aesthetic qualities of thin-walled cast-iron castings fabricated in furan resin sand. Microscopic examination and microanalyses of chemistry indicated that under the coat of paint covering the surface of a thin-walled casting, layers of oxides could be found presence of which can be most probably attributed to careless cleaning of the casting surface before the paint application process, as well as corrosion pits evidencing existence of damp residues under the paint layers contributing to creation of corrosion micro-cells

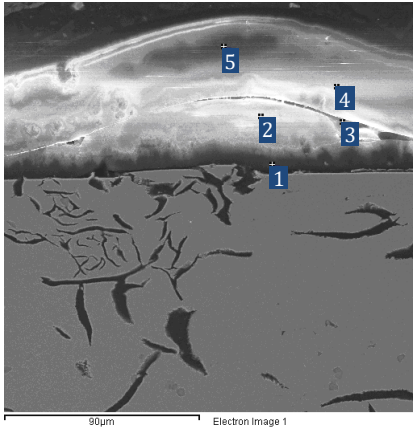
Metallographic analysis of specimens cut out in the plane perpendicular to the painted surface allowed to conclude that two paint coats were applied in the production process. The coat differed from each other in chemical composition, and in particular in chlorine content. Example results of metallographic examination of the paint coat are presented in Fig. 1. The first coat was rich in chlorine (above 17% Cl), while the second revealed low chlorine content (0.44–1.89% Cl, Fig. 1).

Fig. 1. An example specimen microstructure in transverse section with two layers of paint. Note a discontinuous chlorine-rich paint layer (point 2) and continuous layer of paint with low chlorine content (points 4 and 5)

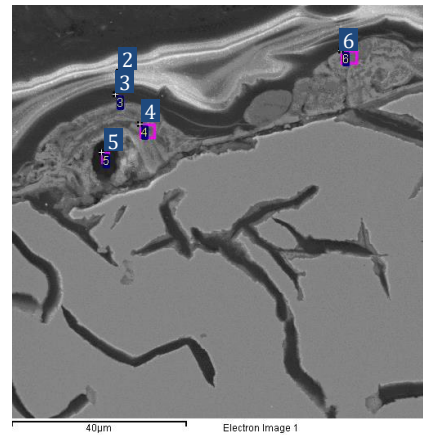
Results of microscopic examination indicate presence of corrosion traces passed over in the surface cleaning process in the form of convex oxide particles adhering to the casting surface (Fig. 2). This is evidenced by presence of a thin paint layer over the areas where oxide particles are found. Observed were also oxide layers adhering to casting surface and covered with a paint coat of normal thickness (Figs. 3, 4). Moreover, discontinuities of the paint coat could be visible with layers of oxides adhering locally to the substrate (Figs. 5, 6) and corrosion pits emerging on the casting surface, filled with oxides and covered with a layer of paint (Figs. 7, 8). This suggests that the paint could be applied onto a surface of casting some areas which were dampened. In presence of moisture, already under the paint layer, the corrosion process could develop penetrating then the casting material. It turned out that easy corrosion paths run through separation surfaces between flake graphite precipitates and the matrix. The corrosion process was intensified by presence of chlorine which most likely came from the paint used to coat the product.

Fig. 2. An example specimen microstructure in transverse section. Note oxide particles with convex shapes adhering locally to casting surface and covered with thinned coat poor in chlorine

Location of oxides found on the substrate surface onto which the paint coat was applied suggest two main causes of their presence. The first is the failure to remove oxides from metal surface. This is evidenced by presence of oxides adhering to the casting surface and the paint coat covering them being thinner than in the areas free from oxides. The second cause consists in the casting surface retaining locally some moisture which, in presence of chlorine coming most likely from the paint, became an electrolyte contributing to creation of micro-cells. In such cases, corrosion penetrated deep into the casting wall.

- To ensure that surfaces of painted cast-iron castings will maintain high aesthetic qualities, it is necessary that the substrate will be thoroughly cleansed of any traces of corrosion and made free of micro-residual damp.
- The used paint should not contain chlorine, as presence of the element in areas with micro-residual damp results in occurrence of corrosion micro-cells, creating conditions for penetration of corrosion deep into the casting material.
- The paint coat should have no discontinuities exposing surface of the casting, because in conditions of free access of damp, in particular in atmospheres typical for maritime regions, local corrosion centres can be created.

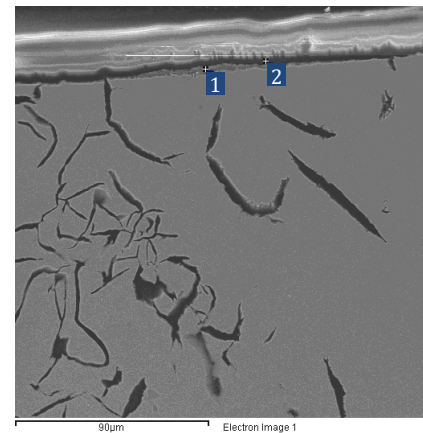
Fig. 3. An example specimen microstructure in transverse section. Note a layer of oxides adhered locally to the casting surface and covered with a layer of paint with similar thickness

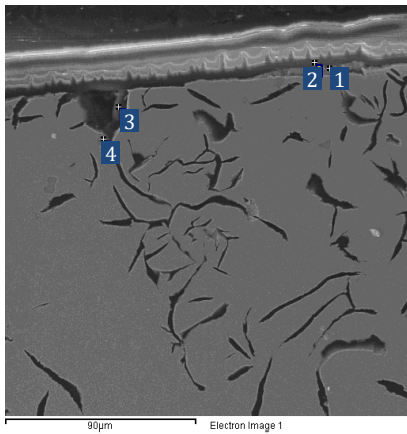
Fig. 4. An example specimen microstructure in transverse section. Note a layer of oxides adhered locally to the casting surface and covered with a layer of paint with similar thickness

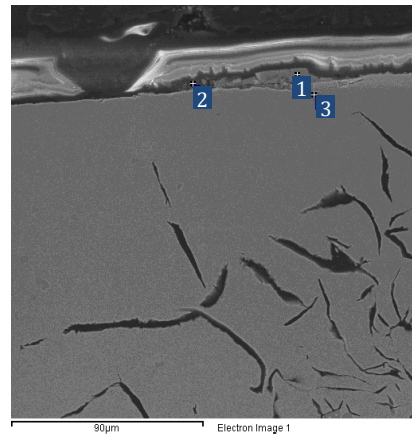
Fig. 6. An example specimen microstructure in transverse section. Note a layer of oxides adhered locally to the casting surface covered with a layer of paint with diversified thickness and flat face. Note also discontinuities of the paint coat

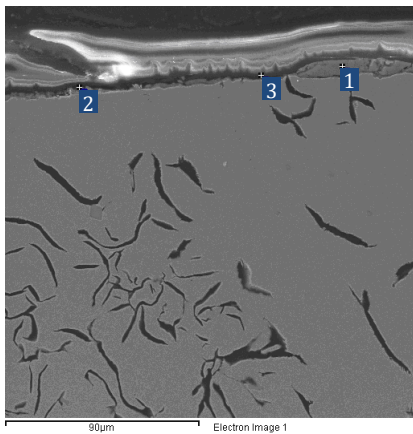
Fig. 5. An example specimen microstructure in transverse section. Note a layer of oxides adhered locally to the casting surface covered with a layer of paint and discontinuities of the paint coat

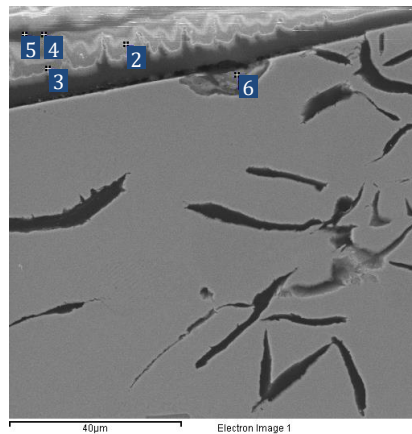
Fig. 7. An example specimen microstructure in transverse section. Note a corrosion pit on casting surface filled with oxides (point 6), covered with a layer of paint in which the first coat is characterised with low chlorine content (points 2 through 5)

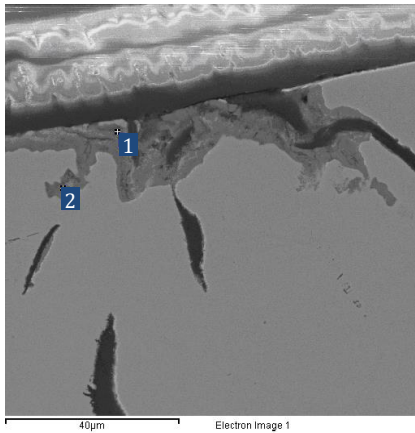
Fig. 8. An example specimen microstructure in transverse section. Note a corrosion pit on casting surface filled with oxides at presence of chlorine (points 1 and 2), covered with paint coat
