Analysis of a Castings Quality and Metalworking Technology. Treasure of the Bronze Age Axes

Metallurgical investigations of axes with bushing were performed in respect of the casting technology and quality of obtained castings. Macroscopic observations allowed to document the remains of the gating system and to assess the range and kind of casting defects. Light microscopy revealed the microstructure character of these relicts. The chemical composition was determined by means of the X-ray fluorescence method with energy dispersion (ED-XRF) and by the scanning electron microscopy with X-ray energy dispersion analysis in micro-areas (SEM-EDS). The shape and dimensions of cores, reproducing inner parts of axes were identified on the basis of the X-ray tomography images. Studies reconstructed production technology of the mould with gating system, determined chemical composition of the applied alloys and casting structures as well as revealed the casting defects being the result of construction and usage of moulds and cores.

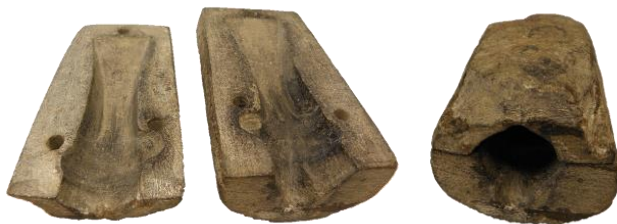
Fig. 1. Mould from foundryman graves, the Legnica cemetery (1100-700 BC); Stone mould for casting of axes [5]

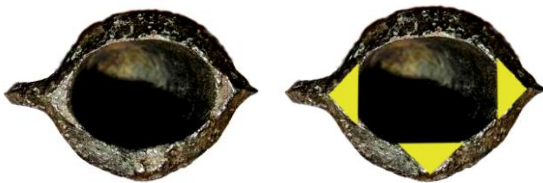
Fig. 4. Axe, visible remains of gating systems – marked in yellow (axe No. NG21)

The gating system with introducing channels is the waste product, usually subjected to remelting. The snap-off or cut-off by means of sharp tools from the rough casting left traces on the axe circumference. Observations revealed various shapes and placements of gating channels (Figs. 4, 5). Usually there were two channels of the same cross-section, which were symmetrically leading from the gating tank cone to the casting edge. There were also overflow channels assuring the proper mould filling and the removal of gases and the metal excess from the mould.

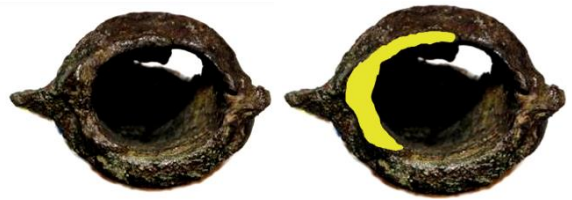
Fig. 5. Axe, visible remains of gating systems – marked in yellow (axe No. NG25)

Numerous surface defects were noticed on castings. There were flashes along the line joining the mould, being a result of not sufficient fitting of mould halves, which were not removed during the surface treatment (Figs. 6b, 7b). Another typical casting defects, deciding on the castings quality are mainly external bubbles and incomplete fillings – called in the foundry environment as misrun (Fig. 6a). External bubbles are formed when gases and air bubbles cannot get out, since the mould has too low permeability [18-21]. Low permeability together with insufficient flowing power can bring the misrun occurs on the cast surface, as observed on figures 5 and 7a.

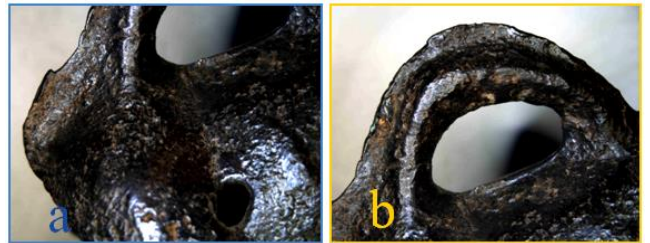
Fig. 6. Axe (No. NG7) with remained elements of the gating system and casting defects: incomplete filling - misrun (a) and flashes along the line joining the mould (b)

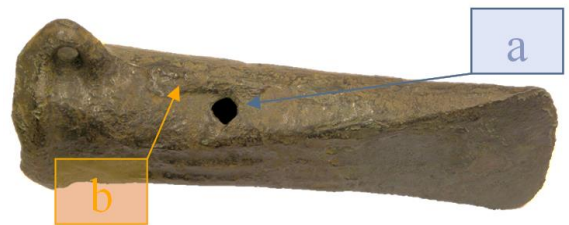
Fig. 7. Axe (No. NG26) with casting defects: incomplete filling - misrun (a) and flashes along the line joining the mould – casting seam (b)
