Cracks in high-manganese cast steel

A. Chojecki^{a*}, I. Telejko^b

Abstract

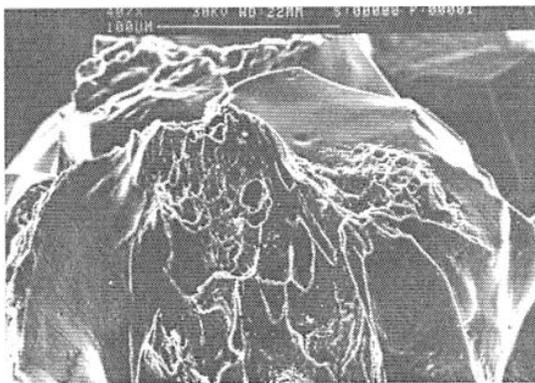
Fig. 6. Plastic deformation in the sample failed at 1230 °C

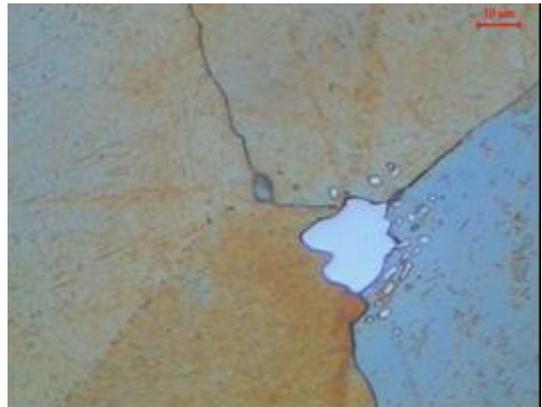
Fig. 11. Carbides in high manganese steel after 3h at 1050 °C and water quenched. Solidification modulus of casting 9 cm

On the surfaces of fracture of heavy high manganese cast steel the inclusions of carbides $(Fe,Mn)_3C$ are frequently observed [1], suggesting the insufficient heat treatment - too low temperature or insufficient time of operation. Authors decided to verify this thesis. The kinetic of the solution of carbides in very heavy castings was studied. The cylindrical 100 mm dia samples of Hadfield steel were cast in insulated mould. Insulation has increase the physical solidification modulus about 45 – 50 % and the solidification time was 2.25 time longer then in silica sand mould. The samples were heat treated 2, 5, 7 or 10 hours at 1050 °C. After water quenching the sample were cuted. The structure of steel was examined for the determination of the quantity of carbides. The results are presented in the Table 2. In Figs. 10-14 the structure of the steel is presented. Before the heat treatment over the 10 % of carbides can be observed. The solution is very quick, especially during first two hours. After this time in the structure one can observe a very limited quantity of small inclusions. They cannot acts as the nucleus of fracture, during exploiting of casting. In foundry practice the castings of the wall thickness over 60 mm is treated about 5 hours. Then, the carbides quantity would be less than 0.8% and their dimensions less than 30 μm

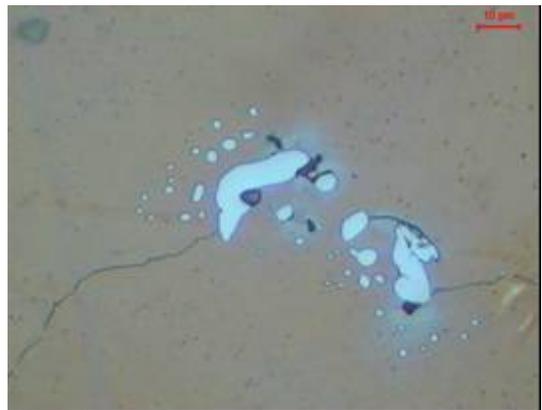
Fig. 12. Carbides in high manganese steel after 5h at 1050 °C and water quenched. Solidification modulus of casting 9 cm

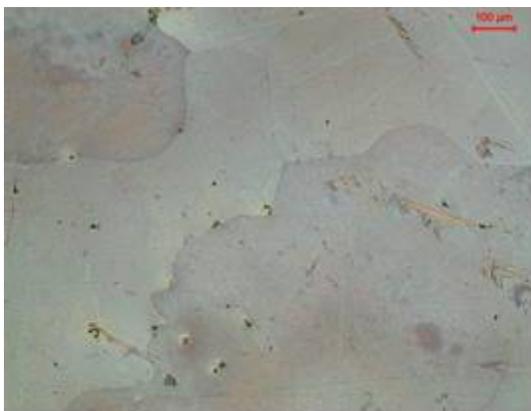
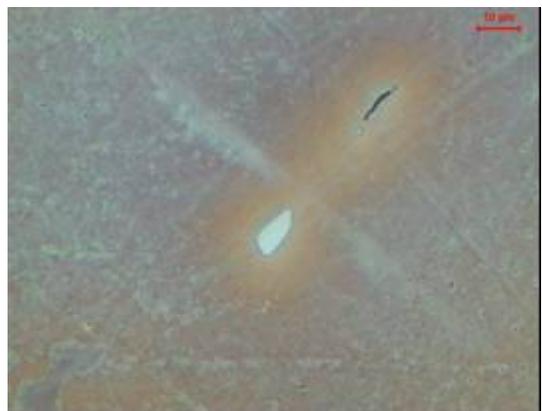
Fig 13. Carbides in high manganese steel after 10h at 1050 °C and water quenched. Solidification modulus of casting 9 cm
