Destruction Mechanism of ZnAl4 as Cast Alloy Subjected to Cavitation Erosion Using Different Laboratory Stands

R. Jasionowski ^{a,*}, W. Polkowski ^b, D. Zasada ^b

^a Institute of Basic Technical Sciences, Maritime University of Szczecin, Szczecin, Poland

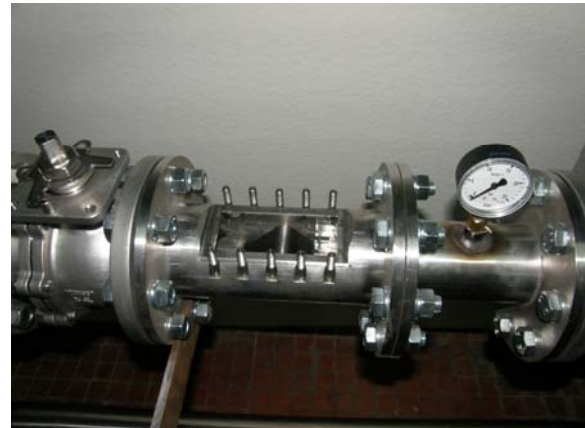
Fig. 3. A view of the cavitation tunnel chamber of the flow stand used in the present work

Finally, the flow stand was also used upon the research (Fig. 3).

In this device the cavitation phenomena is induced by a cross-sectional profile of the flow beam causes a pressure drop, and a local increase of liquid velocity. A cavitation tunnel chamber has dimensions of 55x55 mm with a wedge shaped cavitation inductor. PML2 pump powered by a 15kW engine produces a working fluid pressure of approximately 5000 hPa. The working fluid was tap water with a temperature in the range of 20 to 24 °C. The specimens had a parallelepiped shape with dimensions of 30x55x6 mm. Following exposition times were applied: 15, 60, 120, 180, 240, and 300 minutes.

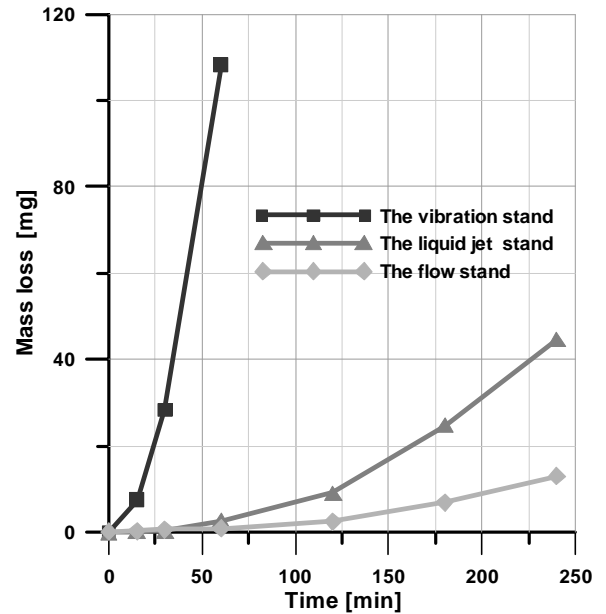
Fig. 8. The mass change vs. time curves for the investigated ZnAl4 as cast alloy

Mass change vs time curves of the destruction process upon testing on the considered laboratory stands are shown in Fig. 8.

Obtained results point toward that the course of cavitation destruction in the investigated material is strongly affected by the way of excitation of the cavitation process. The slowest kinetic of this destruction was recorded for the ZnAl4 alloy upon testing on the flow stand.
